Preservation Tech Notes

WINDOWS NUMBER 22

Maintenance and Repair of Historic Aluminum Windows

Kaaren R. Staveteig
Technical Preservation Services
National Park Service

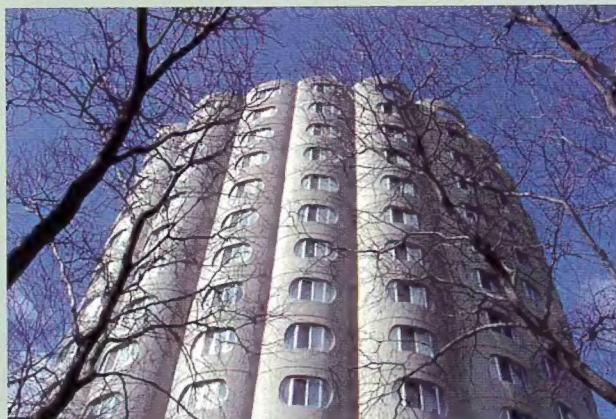
Figure a. One of two identical 16-story senior citizen apartment buildings within the Raymond M. Hilliard Center; each with 182 apartment units. The window openings are elliptical in shape and center on each reeded bay. (Photo: Holsten Real Estate Development Corp.)

The decision was made to save the historic windows for the first four floors of the towers, since they would be most visible from the ground. Units on the first four floors in bad condition were to be replaced by windows in better condition relocated from above floors. Matching aluminum replacement windows were to be installed on the upper floors.

The window survey provided an overall view of the necessary repair work to the historic units. There were standard components within each of the different window types and the aluminum had proved durable where not abused. Thus it would not be necessary to replace large numbers of the entire window assembly within each bay on the lower floors. The windows could be repaired, utilizing parts easily salvaged from other units within a building to replace worn-out or missing ones. In the total project, 336 original windows were to be repaired and 2,016 to be replaced.

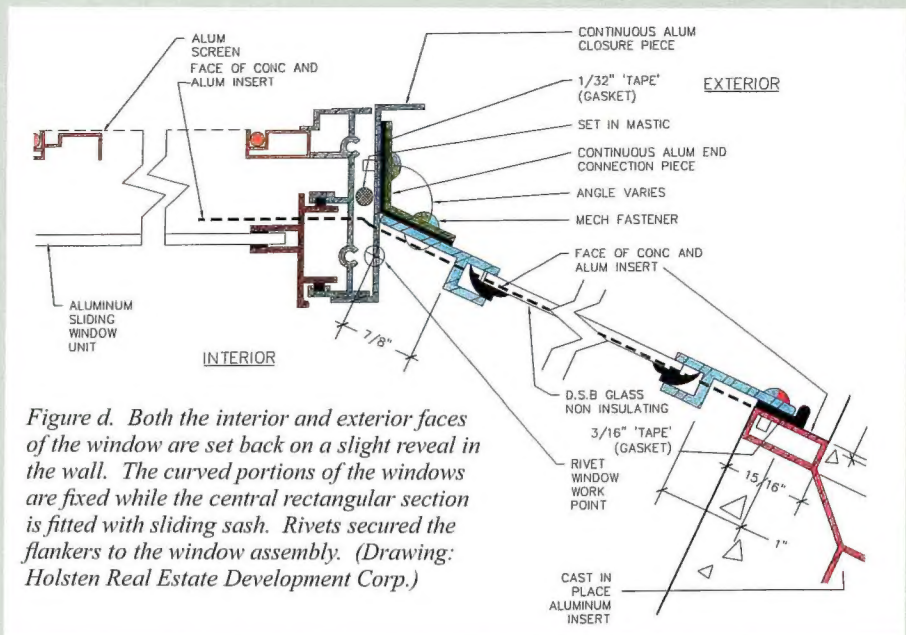
Figure d. Both the interior and exterior faces of the window are set back on a slight reveal in the wall. The curved portions of the windows are fixed while the central rectangular section is fitted with sliding sash. Rivets secured the flankers to the window assembly. (Drawing: Holsten Real Estate Development Corp.)

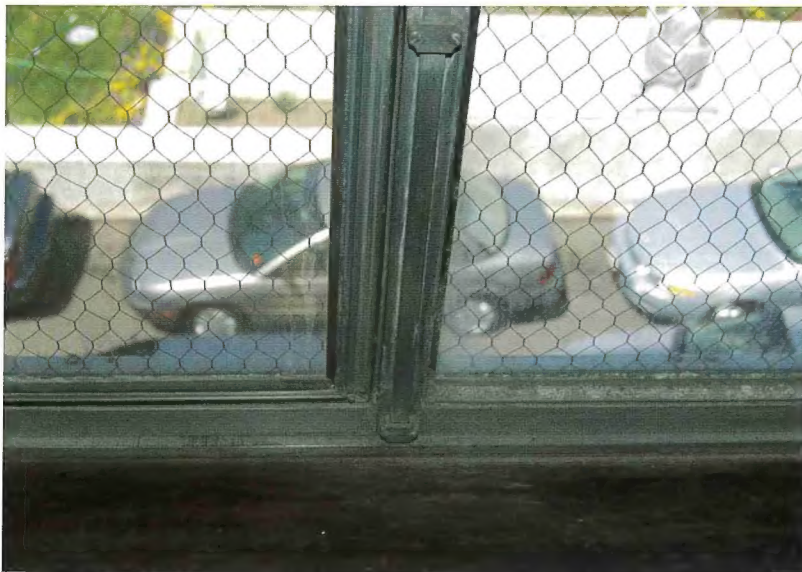
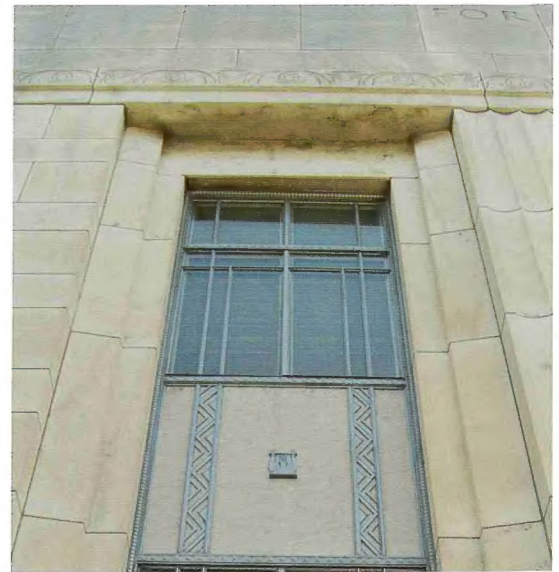
Figure 13. As early as the 1930s, companies primarily making aluminum windows often offered an option for an aluminum storm window, usually on the exterior. The left-hand photograph shows an early interior storm window piggybacked onto the primary window frame at the Folger Shakespeare Library (glass pane on the left). The photograph of the same window, from the outside, shows no indication of an interior storm.
